Therapist Management of a Full-Thickness Facial Burn with a Silicone Lined High Temperature Thermoplastic Splint: A Clinical Case Report

Barbara Knothe, MOT, OTR/L, CHT
September 1996

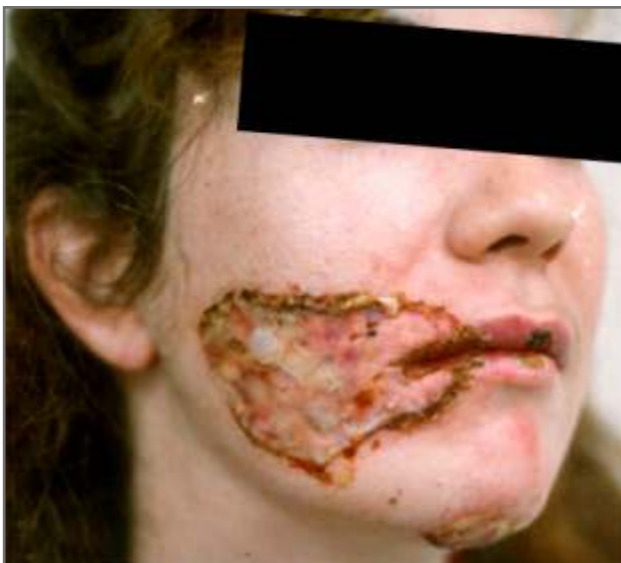
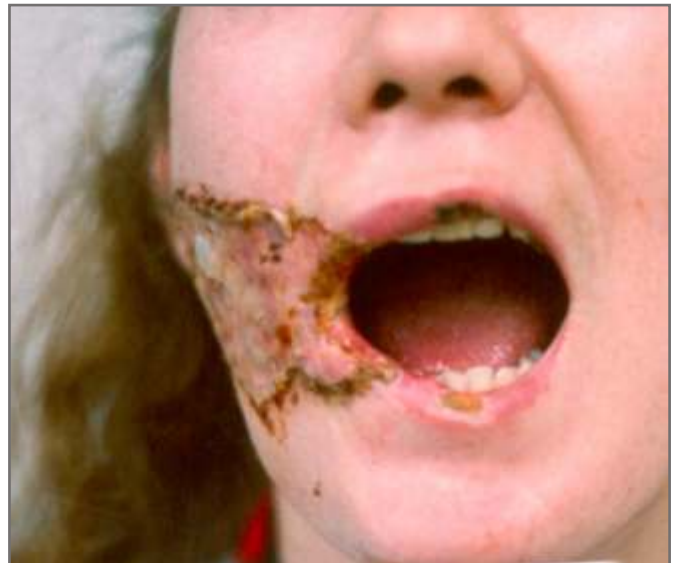
Method: A 28 year old female sustained a 3% TBSA full thickness contact burn injury to the right side of her face including the right oral commissure. She received a sheet graft with a dermal replacement material to cover the area (Figures 1&2). A splinting program was initiated immediately post-operatively and was continued in conjunction with a supervised exercise program focusing on maintaining mouth mobility and symmetry. Once initial healing was attained, a high temperature silicone lined thermoplastic (Silon-STS®) was use to fabricate a ½ face mask that incorporated a pressure rim that reached into and around the right oral commissure (Figures 3&4). This component was an essential part of the design to maintain pressure to the face and mouth together. The patient also performed ROM facial exercises in addition to wearing the mask.

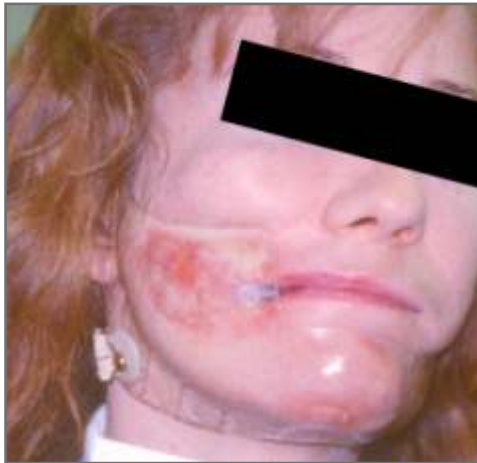
Figure #3

Results: The patient was compliant with the daily wearing schedule and performing the exercise program. The ½ mask was able to be spot heated and modified to increase pressure to the scar over 8 months and this material maintained excellent durability and silicone contact throughout the entire wear. The fit of the mask was enhanced with the silicone lining and allowed for increased fit and contour around the jaw, cheek, lip and mouth. The graft was noted to have a very favorable appearance of flat, smooth, flexible and cosmetically appealing appearance.

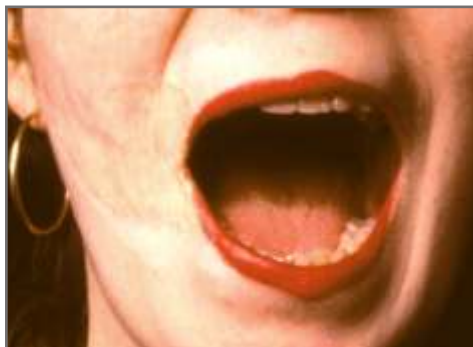
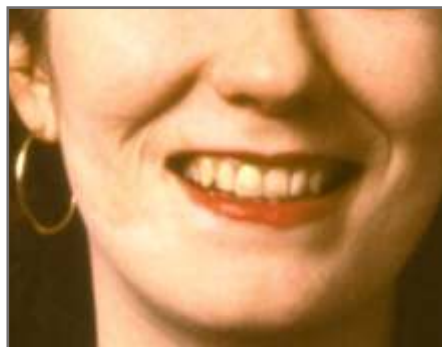
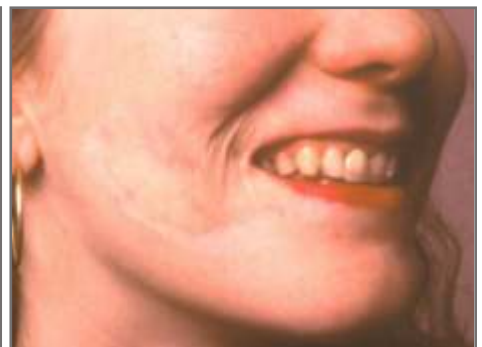
Conclusion: This patient had a significantly improved cosmetic outcome utilizing the Silon-STS® material in conjunction with a supervised exercise program and compliant wearing schedule (Figures 5&6). ROM of the mouth in both vertical and horizontal planes was within functional limits and no deficits in ADL and mobility were noted post treatment with this device. This material demonstrated identical characteristics as compared to conventional high temperature materials used in burn rehabilitation. Additionally, the added benefit of a silicone lining allowed for increased fit, transparency and comfort increasing patient compliance and satisfaction with the overall device. The Silon-STS® material proved to be an effective choice in the management of facial scarring and is a material of choice for the burn rehabilitation professional to effectively manage scar hypertrophy.
